Article

# Seasonal Change in Techno-Economic Properties of Waterfront Structural Pinewood

**Keywords:** pinewood; waterfront structures; value engineering

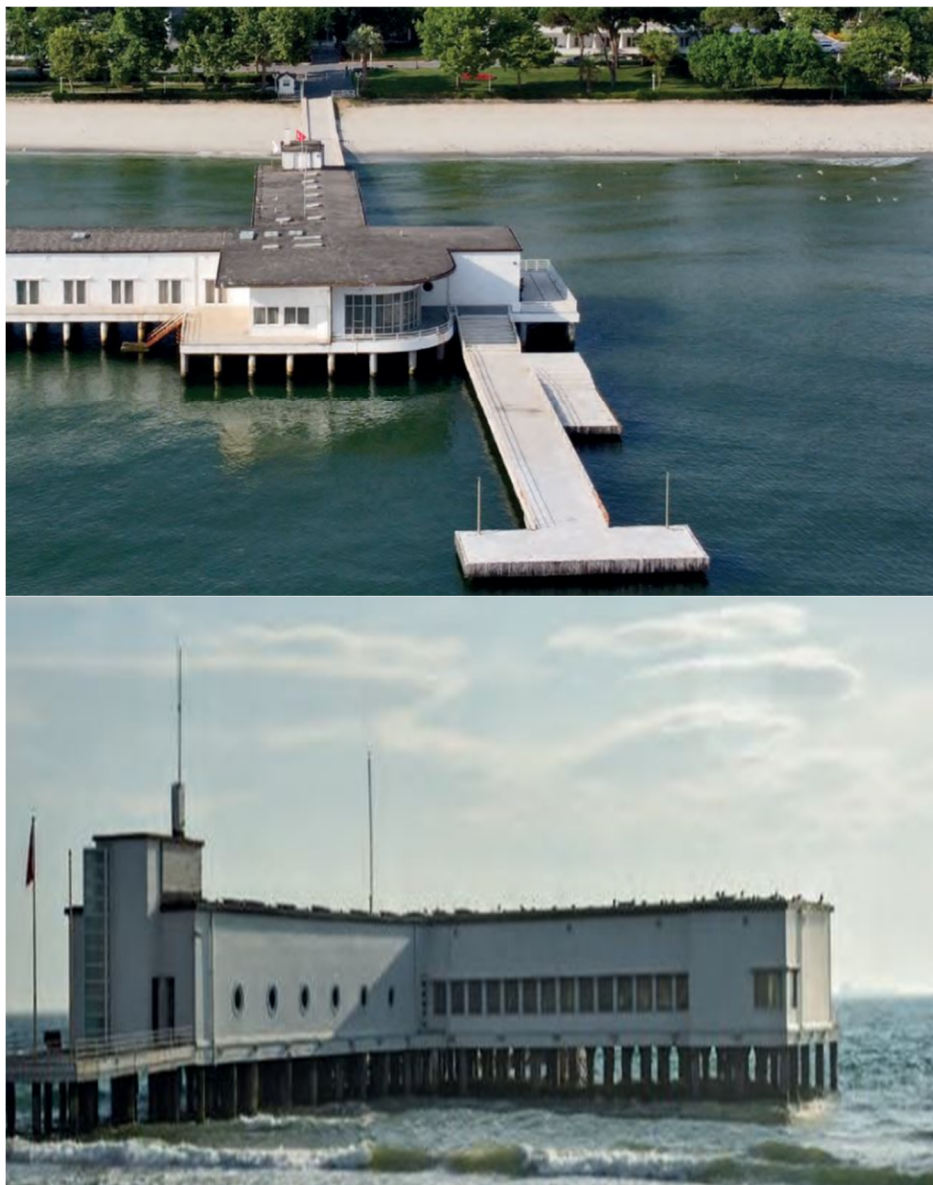
**Figure 1.** Different views of the studied building and placement of specimens [78].

Municipality, the Atatürk Marine Mansion, which was connected to the shore by a bridge spanning 70 m and built on concrete piles anchored into the seabed (see Figure 1), was created as a summer residence for Atatürk, the founder of the Republic of Türkiye [77].

Today, the mansion, which serves as a museum with its single-story L-shaped wooden structure made of specially designed materials and fittings, consisting of a large living room, library, relaxation area, bedrooms, and a bathroom, has undergone significant renovations, replacing part of the structure with reinforced concrete and, despite being a wooden structure, it is built on reinforced concrete legs supported by the sea [77]. However, the mansion has suffered damage from various factors such as seawater, marine environment, climatic conditions, and other events. To protect the mansion, precautions have been taken to maintain its structural integrity. Different views of the studied building and the placement of specimens are shown in Figure 1.

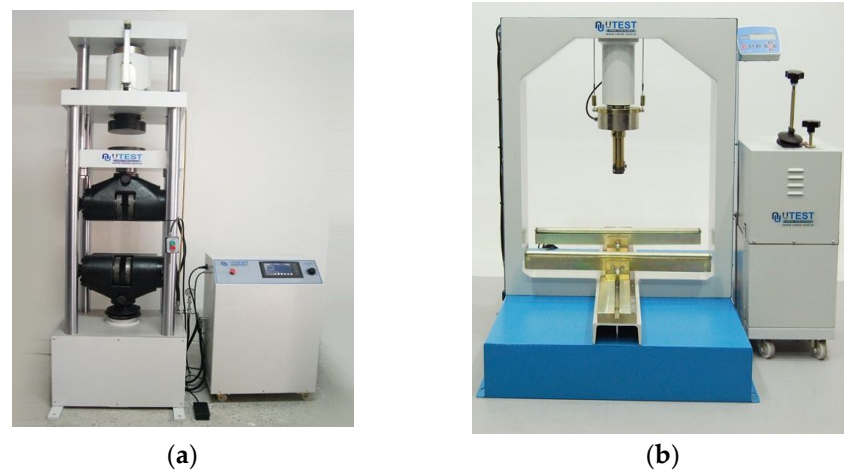
**Figure 4.** The applied laboratory test for the specimens: (a) universal tensile test machine; (b) bending test machine.

In this research, both prepared and naturally aged samples underwent a tensile test with the hydraulic universal testing machine marked as UTM-4000 and a bending test with the electromechanical universal test device labeled as UTM-8050, as illustrated in Figure 4. The tensile test involved pulling the samples at a steady speed of 2 m/s while monitoring their strength and elongation up until the point of fracture. Similarly, the specimens were subjected to a 3-point bending test at a constant speed of 2 m/s, and the strength and deflection at the center of the samples were recorded. These tests were conducted at the university’s laboratories.

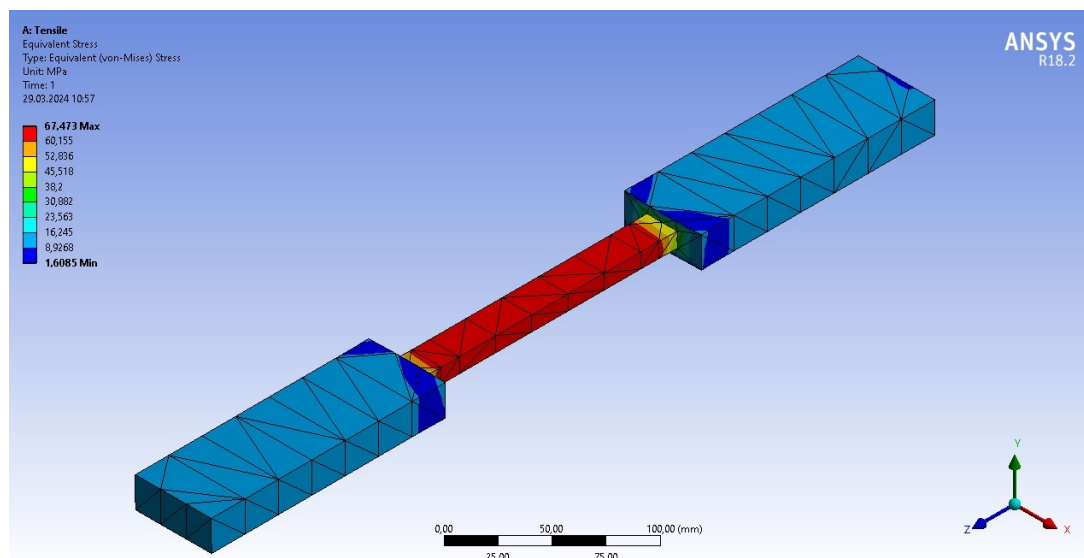
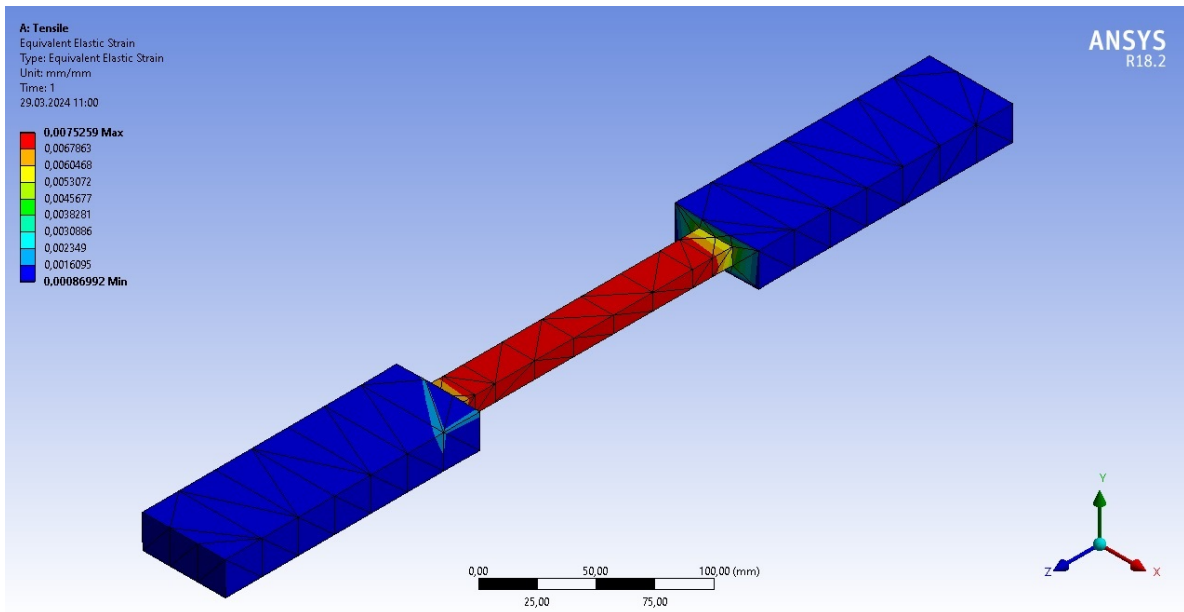
Figure 5. Stress and strain analysis of specimens for the tensile test: (a) tensile stress; (b) tensile strain modeling.

The samples were carefully prepared and left to age naturally in a predetermined seashore area. During the first phase of each period, the original three samples underwent both tensile and bending tests in the lab. At the end of the period, new samples were taken from the same location and every third sample was subjected to the same tests. This process was repeated over the course of several seasons, with each period lasting three months to reflect the changing seasons in Türkiye. The maximum tensile and bending strength values were recorded from the tests. Due to cultural heritage restrictions, the test specimens were monitored for three years and underwent the same procedure annually. The maximum tensile strength (MTS) and maximum bending strength (MBS) results were obtained for each sample, and the average results for all three years were presented in Tables 2 and 3 for evaluation purposes. These experimental values were then used as input for numerical analysis in ANSYS Workbench v.18.2 software. Figures 5 and 6 illustrate the simulation results for the April–May–June period, and similar results were computed for each period and provided between Tables 2. The simulations yielded equivalent (von Mises) tensile stress (Figure 5a), equivalent (von Mises) bending stress (Figure 6a), equivalent tensile strain (Figure 5b), and bending deformation (Figure 6b) values.

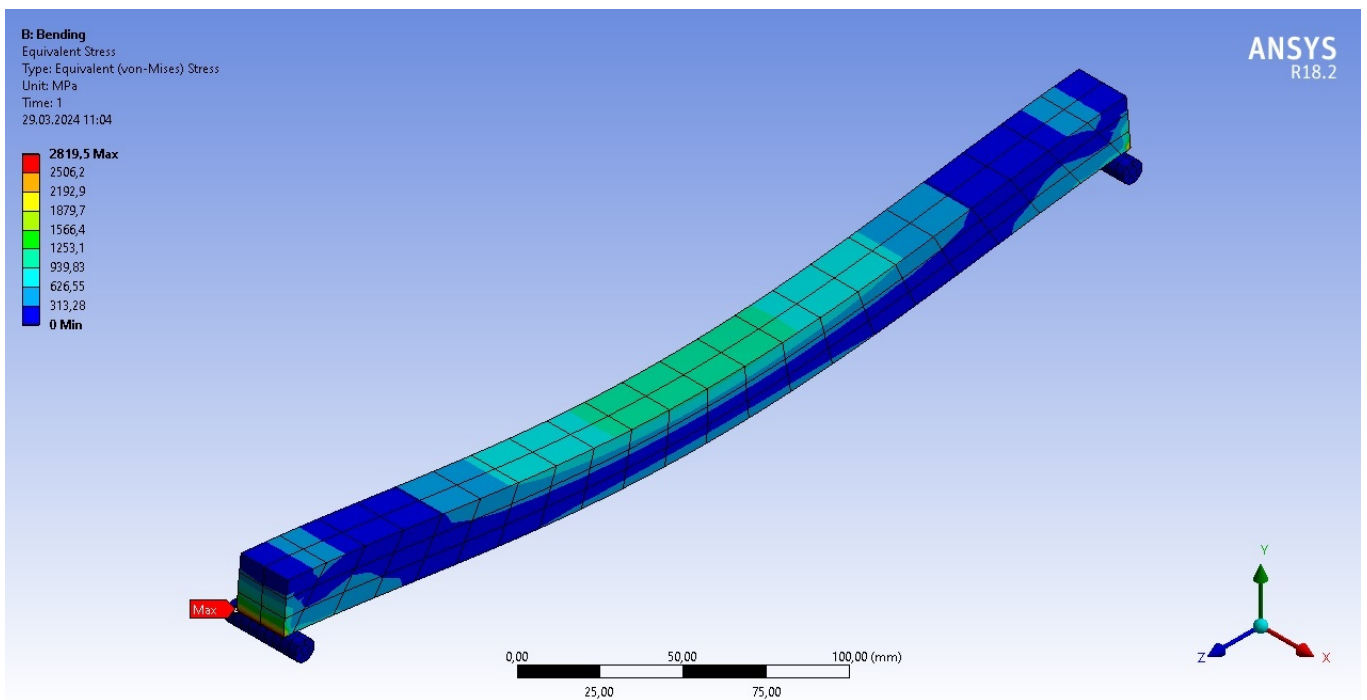
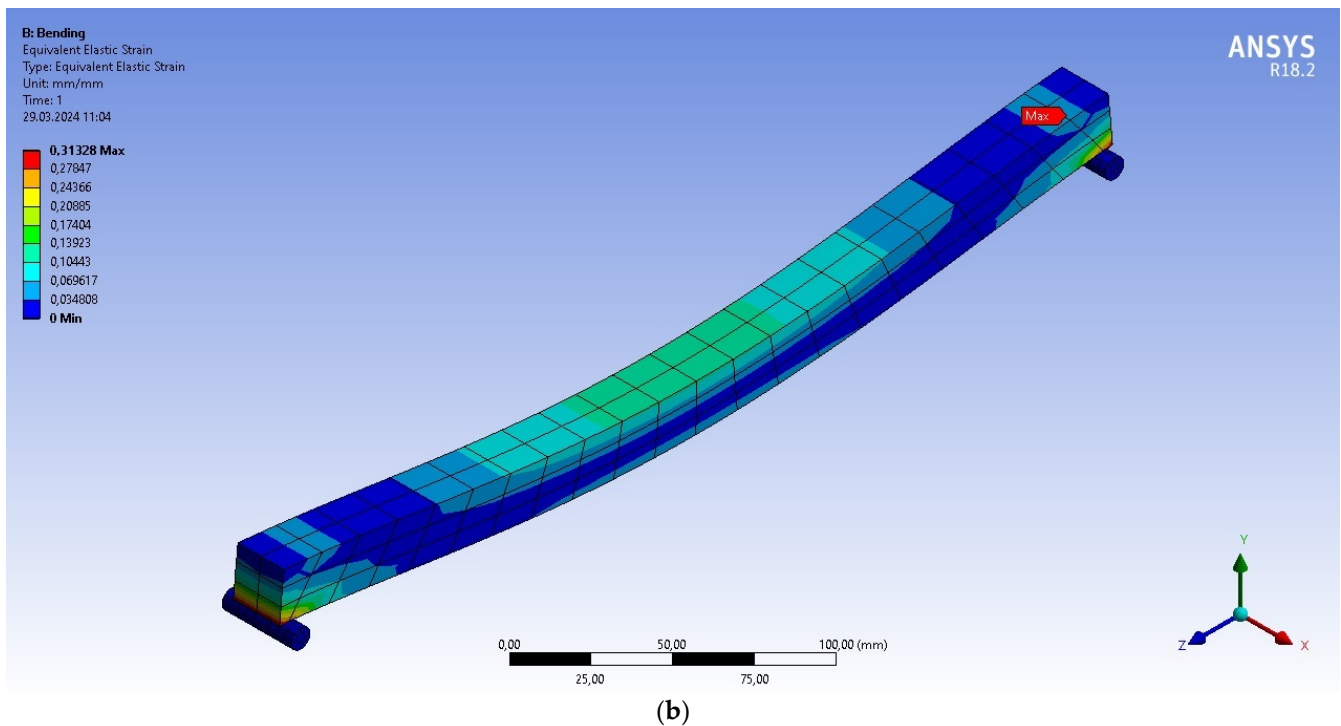
**Figure 6.** Stress and deformation analysis of specimens for the bending test: (a) bending stress; (b) bending deformation.

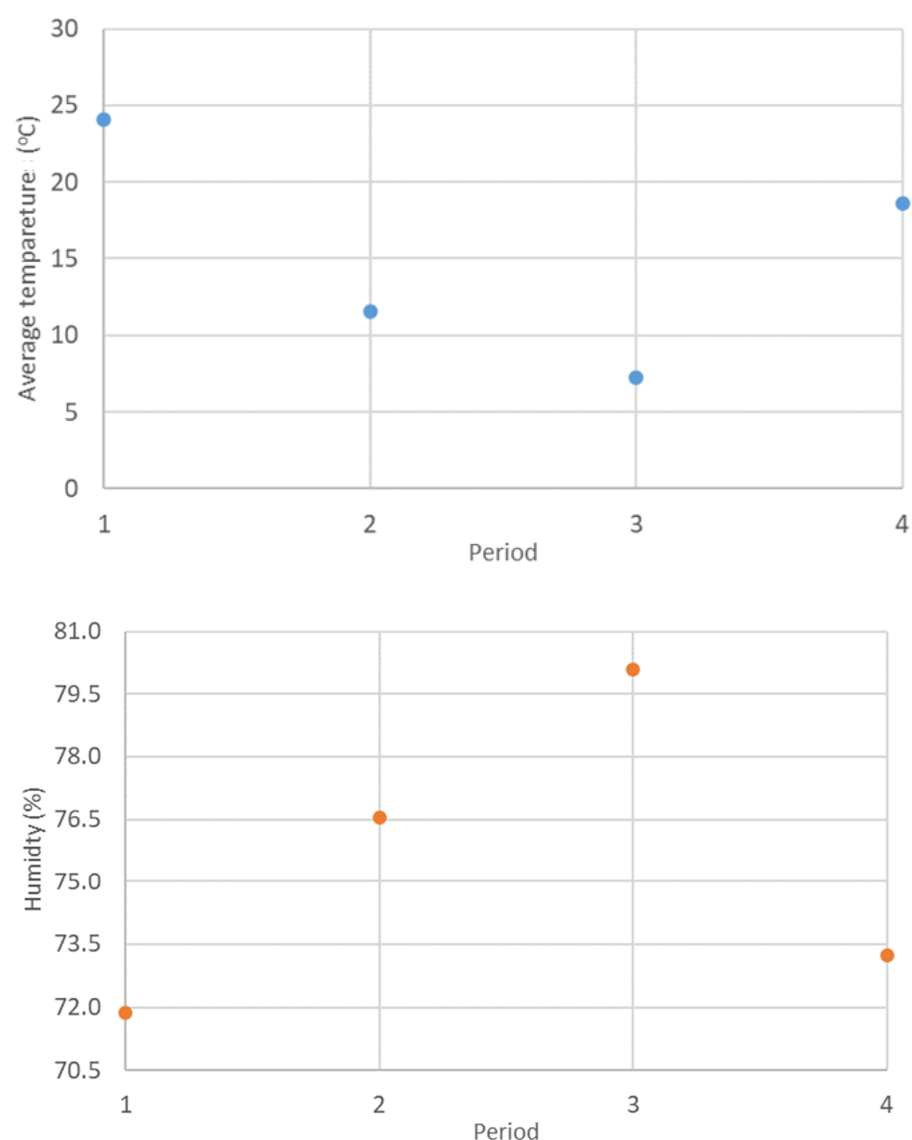
**Figure 7.** The variation in average temperature and humidity depending on the pursuing periods.

To assess the impact of seasonal and environmental factors on our study, we also gathered data on temperature and humidity from a nearby meteorological station, located 500 m away from the Atatürk Marine Mansion where our research was conducted. Table 2 displays the average values for each season, and we note a decline in temperatures from the first to the third season, followed by a rise in the fourth season. Conversely, humidity levels increase from the first to the third season and continue to rise in the fourth season. In the next section, we compare and evaluate the tensile stress values of our specimens for each season, analyzing their strength and deformation. To provide a visual representation of our findings, we have included Figure 7, which illustrates the relationship between

temperature and humidity across the seasons. There is a negative correlation between temperature and humidity, resulting in a decrease in humidity as temperatures rise. Additionally, the warmest temperatures tend to occur in the 1st and 4th periods due to seasonal conditions.

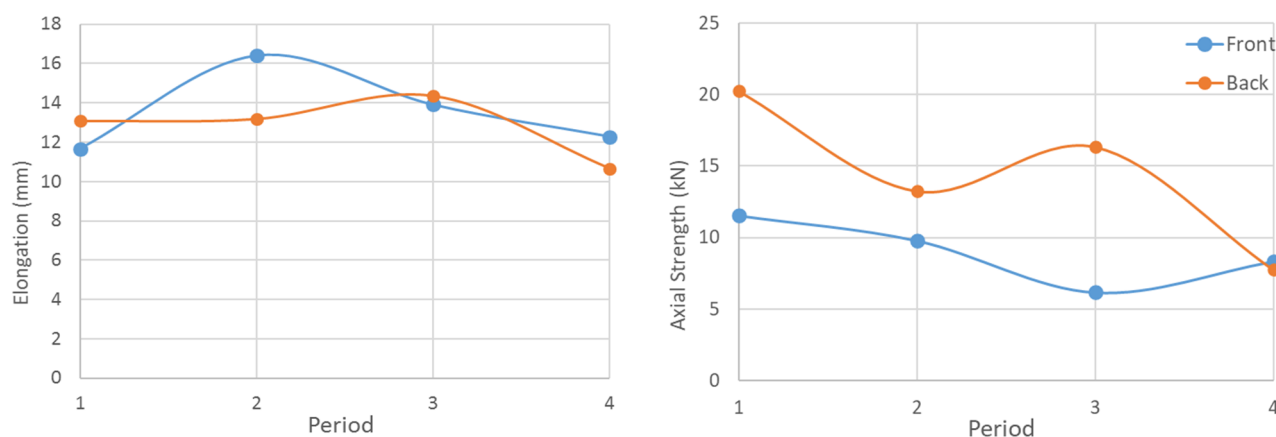
**Figure 8.** The variation in axial strength (left) and elongation (right) of specimens versus pursuing periods determined from tensile test.

Based on Figure 8, it appears that the temperature distribution over time aligns with the axial strength variation in pinewood material, particularly for samples taken from the front-facing side of the building. This suggests that direct sunlight and a more saline environment can affect the strength of pinewood material in building materials. On the other hand, back-facing samples are more susceptible to dry air conditions compared to front-facing ones, and this discrepancy has a nearly twofold impact on the material's axial strength [83]. When investigating the axial deformation of materials, it seems that humidity also has a greater influence on the elongation, or axial strain, of the material compared to temperature [84]. To address this, in addition to scheduling maintenance during optimal times, thermal modification can be a viable solution for improving the mechanical properties of wooden structures, including strength, dimensional stability, and durability while reducing heterogeneity [85,86]. A study by Zhang et al. [87] on bamboo samples revealed that vacuum thermal modification enhanced dimensional and moisture stability, axial compressive strength, and hardness. In general, elongation, or ductility, of the material increased, but air conditions affected front- and back-facing specimens differently. While both sides experienced an increase in elongation with humidity, front-facing specimens in the second period showed a greater increase compared to back-facing ones. However, front-facing samples responded differently to sunlight and a saline environment, and when humidity levels peaked in the third period, the elongation of back-facing specimens continued to rise while that of front-facing ones plateaued.

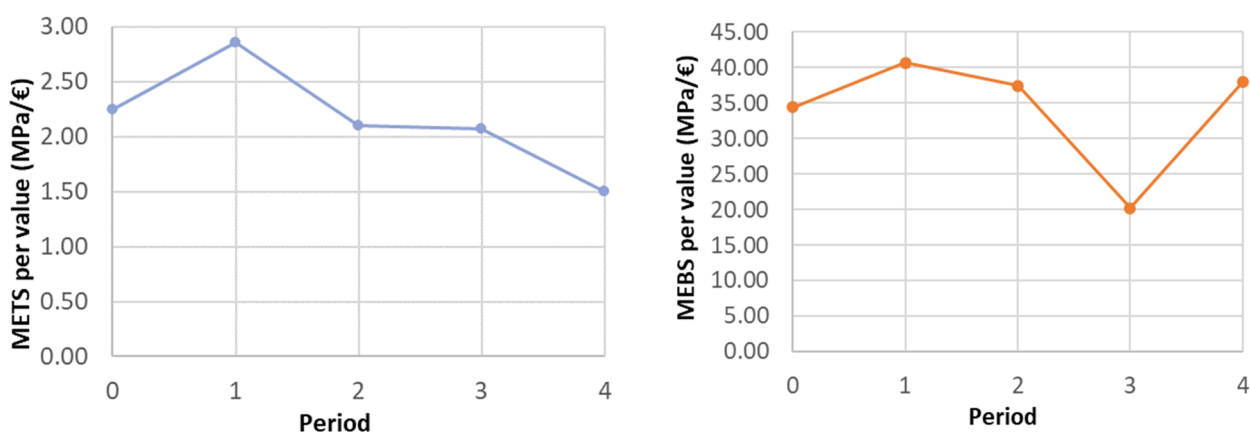
**Figure 9.** The change in per unit values of material over the pursuing periods determined from the tensile test (**left**) and bending test (**right**).

The economic changes in per unit values, as calculated in Tables 4 and 5, are visually represented in Figure 9. It is clear that the curves in both figures increase at first and then dramatically decrease in the third period of the year. The results show that the Maximum Equivalent Tensile Strength (METS) per unit value reaches its lowest point in the fourth period, but the decrement is relatively smaller than in the third period. Additionally, the Maximum Equivalent Bending Stress (MEBS) per unit value reaches its minimum value in the third period, resulting in a very low economic value. However, it does receive a relatively lower increment in the fourth period compared to the previous one. Therefore, it can be concluded that the loss of economic value due to changes in the physical properties of the wooden material mainly occurs in the third and fourth periods, which are exposed to marine weather conditions. Due to concerns surrounding the sustainable sourcing of wood as a raw material and procurement issues (Petruich and Walcher, 2021) [89], the monetary values of timber structures are increasingly crucial compared to other construction methods.

To preserve the economic value and originality of the material, we recommend performing annual maintenance before the start of the third period (i.e., before January). This will ensure optimal maintenance of the building. Currently, the maintenance of entire buildings occurs yearly at varying times without regard for the facade. Moreover, simple water paintwork is applied without considering environmental conditions. This study monitors the effect of environmental conditions on different facades and highlights the rationale behind selecting a maintenance period that prioritizes both sustainability and optimal economic conditions. The experimental results also indicate that protection against saline environments is necessary. As a result of this study, the third period is deemed the best option for maintenance, and various solutions can be adapted for different facades, such as waterproof or nanomaterials, to improve and protect wooden materials [90,91]. A preventative method that can also be employed is safeguarding. Mi et al. [92] conducted a study on the Yingxian Wooden Pagoda to establish an effective repair and restoration method for safeguarding the wooden components of historical buildings. They analyzed a few aged samples using various chemical techniques to determine the effects of sunlight and oxidation on the structure and to develop strategies to prevent surface deterioration.
