# *Retrofit planning for the performance gap: results of a workshop on addressing energy, health and comfort needs in a protected building*

# Retrofit Planning for the Performance Gap: Results of a Workshop on Addressing Energy, Health and Comfort Needs in a Protected Building

**Keywords:** performance gap; building simulation; energy retrofit; health; thermal comfort; listed buildings

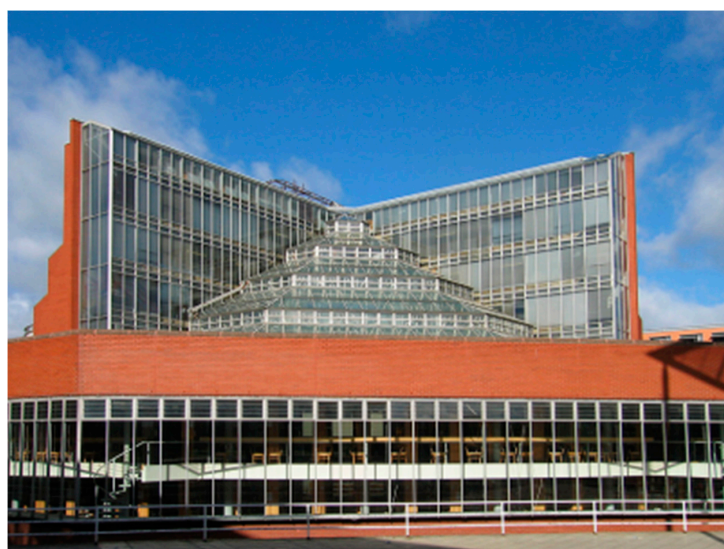
Figure 1. Faculty of History.

The selected case study was the Faculty of History in Cambridge (Figure 1). The design of James Stirling was selected based on an architectural competition in 1962. From the beginning, there were concerns about the building's environmental performance "the building would be subject to solar heat to a fairly large extent" (EMBS files 1963). The building was funded by the Universities Grants Committee (UGC), which meant that the funds had to be spent within a certain time frame and there was pressure to reduce the number of design iterations. The project was well funded; the contract price was £104/m<sup>2</sup> which amounts to £2440/m<sup>2</sup> at current prices. The design accommodates the history faculty, with an L-shaped stacked block of 6 levels enclosing a large fan-shaped glazed central space that houses the library. Early in construction, a poor relationship was reported amongst all parties, along with time/cost overruns and leaks were noted during the handover of the building. Due to neighbors' complaints an adjustment and reorientation of the building was made. After two decades of contending with construction and thermal comfort issues, demolition was considered in 1985 but the building was conserved and "grade II" listed in 2000.

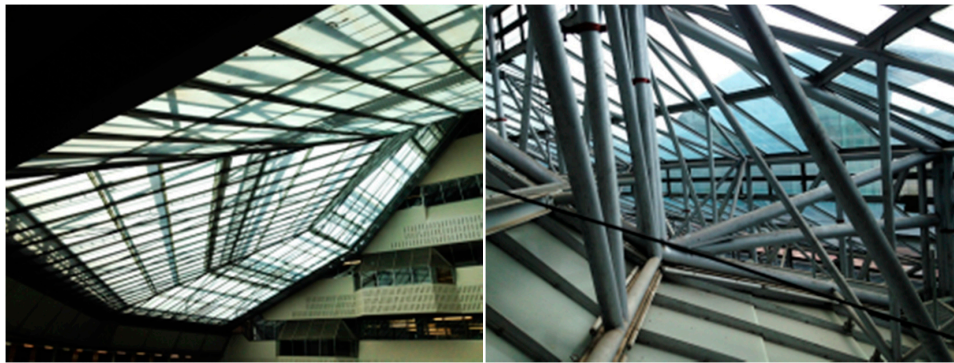
**Figure 2.** Glazed, double-skin roof of the library from inside the library (left) and inside the cavity (right).

The main reason for the poor thermal comfort and high energy use is that 75% of the envelope above the plinth is standard industrial glazing, along with the giant stepped-pyramid skylight of the

library (Figure 2). The glazed, double-skin roof in the library was meant to act as a light diffusing layer where the inner layer was obscured to prevent glare and to give shadowless light in the reading area. This was also designed to insulate the cavity between the two skins so that all the louvres in the vertical steps would be closed in winter and opened in the summer to enable ventilation through the stack effect. Artificial light sources in the cavity and the roof provide an ‘overhead spectacle’; however, the library space and office spaces are prone to overheating in summer (and to draught in winter). The noisy extraction fans in the library were never used and small air-conditioning units have been placed in the administrative corridors. Offices have draughty glass louvres for ventilation, along with secondary glazing and venetian blinds that have been installed during later renovations. It was predicted (somewhat dismissively) as early as 1968 that “controls will be fouled up through mismanagement by the humanities-oriented occupants who are below the average in mechanical literacy and competence, while the occupants will take verbal revenge on the architects—whereas revenge should be on UGC and their budgets that are too ‘skimpy’ to permit decent environmental installations or idiot-proof control systems” [18].

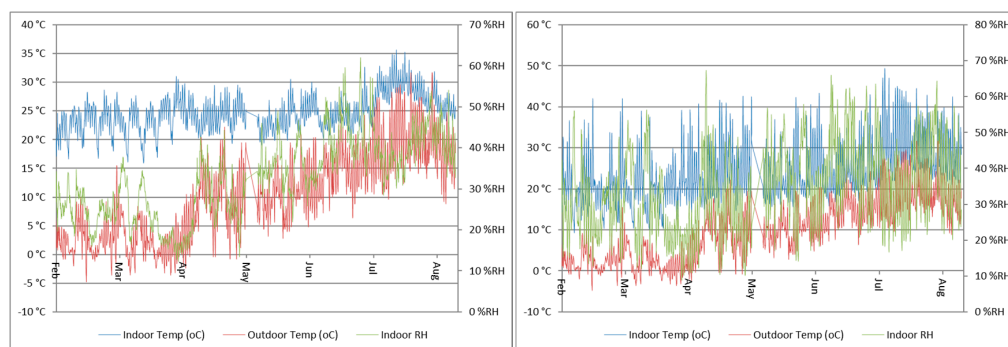
**Figure 4.** Ground Floor Library (Left); 1st Floor Library (Right) (University of Cambridge).

**Figure 5.** Room on the 4th floor (Left); 6th Floor Corridor (Right) (University of Cambridge).

Figures 4 and 5 show the internal temperatures and relative humidity as well as the external temperatures during one year in different areas of the building. According to the results, the building has been thermally uncomfortable in almost all areas (per the definition provided in Table 2). The internal temperature in many areas has reached 35 °C; the indoor temperature in the rooms/offices between July and August has frequently been over 30 °C. The temperature in the main library on the ground floor has also fluctuated greatly and in many cases has exceeded 30 °C. Meanwhile, CIBSE Guide A 2015 recommends average summer operative temperatures of 24–25 °C for libraries and 22–25 °C offices, respectively [23]. This presents serious comfort and health challenges for occupants.

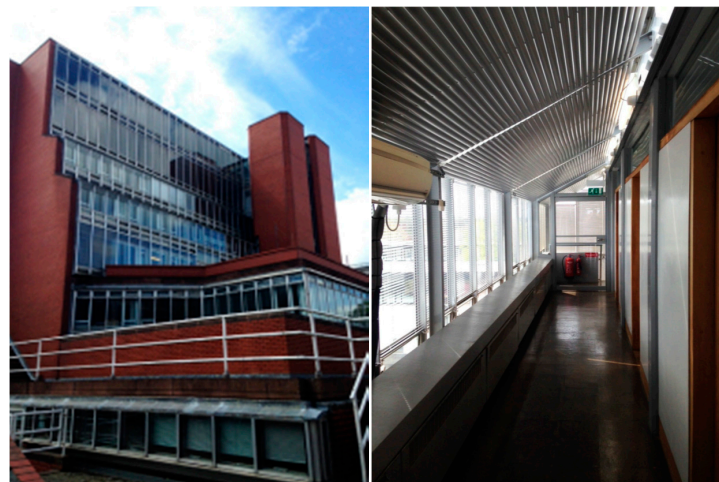
**Figure 6.** Excessive glazing and solar heat gain contribute to overheating.

The situation has been considerably worse in the corridors on the 6th floor (Figure 6) as the temperature has reached nearly 50 °C which is an indicator of severe, and potentially dangerous, thermal comfort conditions for the occupants; the UK Health and Safety Executive and the Chartered Institute of Building Services Engineers recommend maximum indoor temperatures for comfort of 30 and 25 °C, respectively [24]. Extremely high indoor temperatures in the building necessitated the use of air conditioning units, particularly on the higher floors. According to Figure 4, occupants also experience extremely low temperatures (between 10 °C and 15 °C) during winter. Such conditions indicate high heating and cooling requirements in the case study building during both winter and summer. Yet, considering benchmarks, the average electricity consumption of 49.5 kWh/m<sup>2</sup> is rather low. A possible explanation for this may be the seasonal use of the building by the occupants.

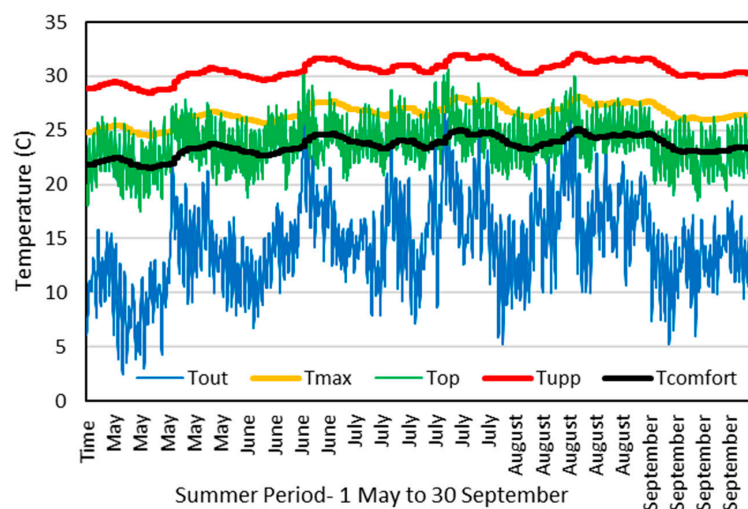
**Figure 13.** Distribution of indoor and outdoor air temperature, operative and comfort temperature in 6th floor considering cross ventilation (scenario 3).

As explained in the methodology section, in order to examine the thermal performance and the level of overheating under different scenarios, adaptive approach for thermal comfort analysis is adopted in this data analysis (CIBSE-TM 52, 2013). The outcome of the data analyses revealed the first two scenarios both failed in all three assessment criteria. However, the third scenario failed only the first criterion (by a relatively small amount) and was successful in fulfilling the requirements of next two criteria. In the third scenario, the percentage of the occupied hours when operative temperature was greater than maximum comfortable temperature reached to 4.9%, which was just less than 2% more than what it should be. Figures 9, 11 and 13 demonstrate the distribution of outdoor air temperatures and indoor operative temperatures and the day-to-day values of maximum acceptable temperature and upper limit temperature together with comfort temperature in office zone in the north wing of the 6th floor.
