Article

# Comparative Study of the Road Roughness Measurement of Roadlab Pro and Roadroid Applications for IRI Data Collection in Nigeria

<sup>1</sup>Ekpenyong, E.E., <sup>1</sup>Abu, A.S.P., <sup>2</sup>Cinfwat, K.Z.,  
<sup>1</sup>Nigerian Building and Road Research Institute, Abuja Nigeria  
<sup>2</sup>University of Jos, Plateau State, Nigeria  
Corresponding Author: Ekpenyong Ekpo Efiom

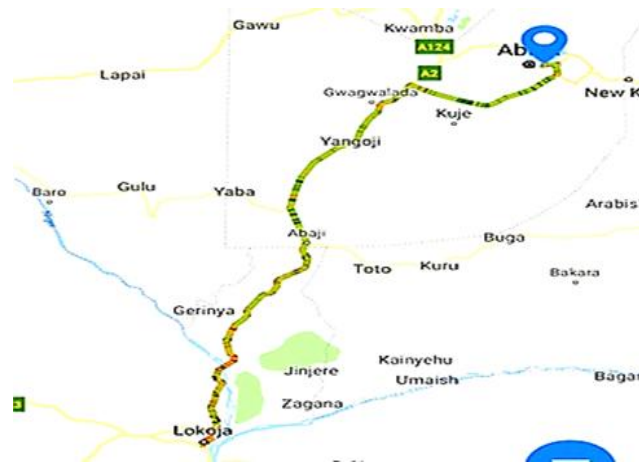
From data collected by RoadLab Pro, total surveyed length is 392.25km with average speed of 87.91km/h. 99.74% of the total survey length recorded an average IRI of 3.13; classified as good. Most section of the road link recorded IRI values classified as good as seen in Figure 2 where significant section of the route link is within the green colour range.

Figure 2: Screenshot of IRI measurement for road link (RoadLab Pro)

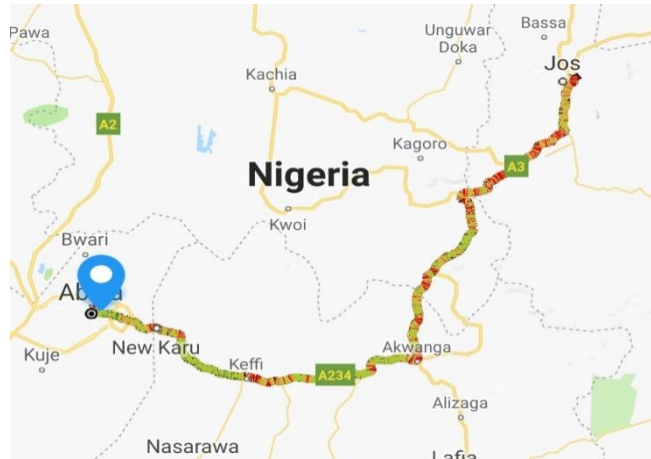
Figure 4: Screenshot of IRI measurement for road link (RoadLab Pro)

From data collected by RoadLab Pro, total surveyed length is 556.86km with an average speed of 75.98km/h. Roughness measurement from the application showed that 98.67% of the total surveyed length was measured with an average IRI of 5.00, classified as fair. Predominantly, the road section recorded IRI values that are categorized as fair with the remaining section, partly good and poor. The visualization of the IRI data retrieved from RoadLab Pro shows that significant part of the road link from Akwanga to Jos as seen in Figure 4 have IRI greater than 6; implying poor condition level.
