# Assessment of Overheating Risk in Gynaecology Scanning Rooms during Near-Heatwave Conditions: A Case Study of the Royal Berkshire Hospital in the UK

Hannah Gough <sup>1,\*</sup>, Samuel Faulknall-Mills <sup>2</sup>, Marco-Felipe King <sup>3</sup> and Zhiwen Luo <sup>4</sup>

**Abstract:** Hospital buildings in the UK are at particular risk to rising summer temperatures associated with climate change. Balancing the thermal needs of patients, staff, and visitors is a challenging, complex endeavour. A case study of the ultrasound area of the Royal Berkshire Hospital's Maternity and Gynaecology building is presented, where temperatures were measured for 35 days in waiting areas, staff offices, and ultrasound scanning rooms, aiming to assess the overheating risk posed to occupants. Local external temperature measurements were used for comparison whereby determining the indoor-outdoor environmental connection. Results show that most rooms had already breached standard overheating thresholds within the study period. Anthropogenic and waste heat from equipment has a noticeable effect on indoor temperatures. Local air-conditioning helped reduce the peaks in temperature seen between 14:00

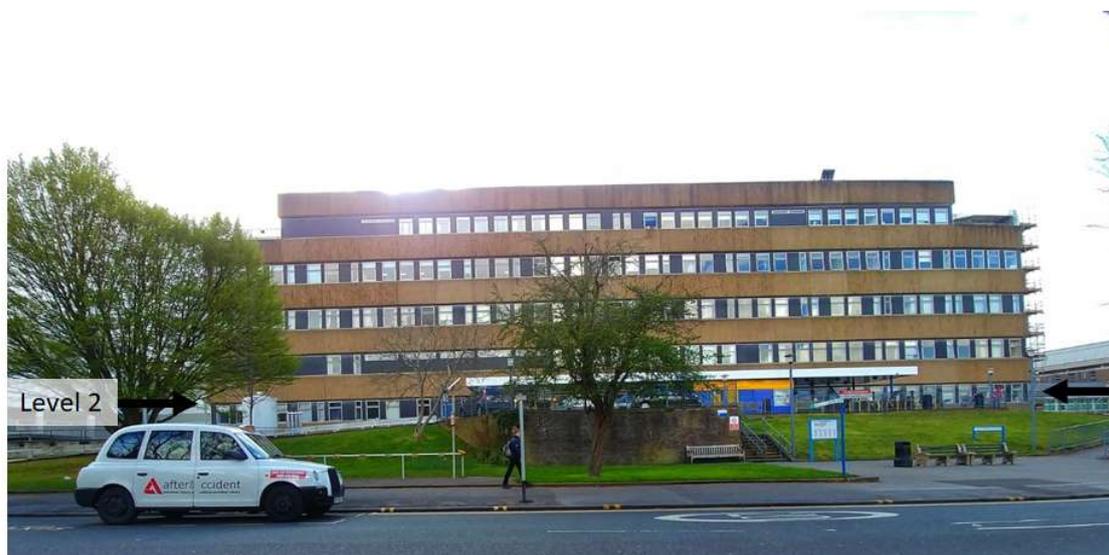
**Figure 1.** Photo of the Maternity and Gynaecology building taken from across the road. The black panels seen around the windows are asbestos. Level two is the ground floor of the building, highlighted by the black arrows, with the two entrances (Figure 2) located under the white awning.

This building was built in the 1960s and constructed of mostly concrete and asbestos with no façade shading. Windows are single-glazed with ill-fitting frames. The building was not designed to facilitate the anthropogenic, IT, and electronic heat loads seen in a modern M and G department. There is a mechanical ventilation system mainly used for heating, but it is turned off in the Summer

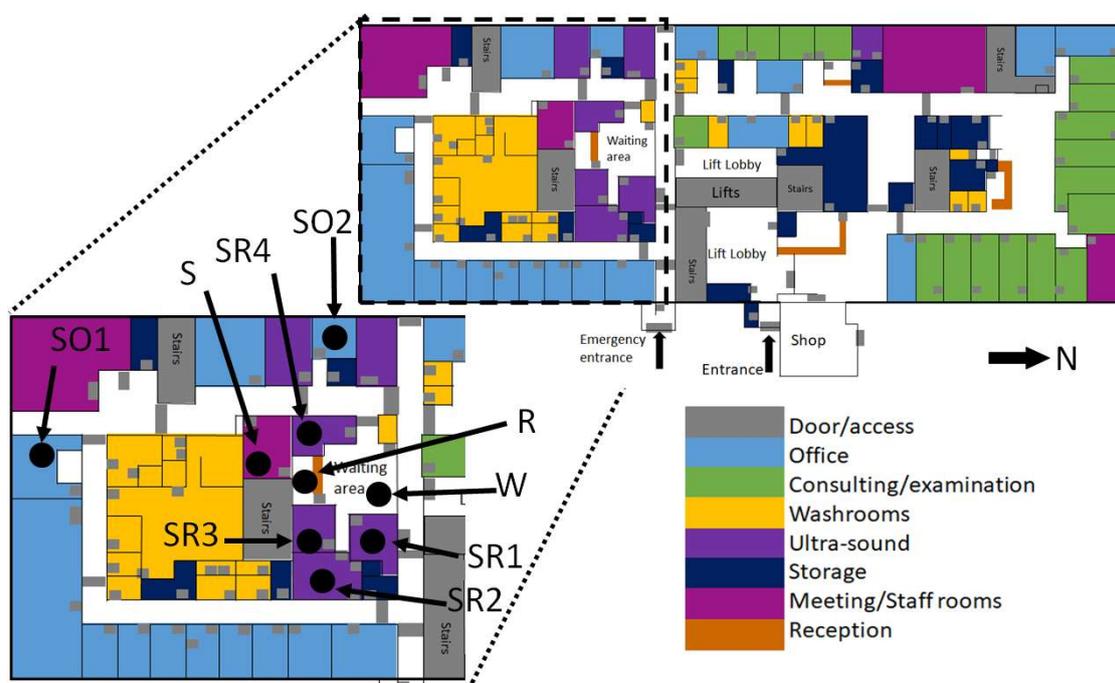
**Figure 2.** Floor plan of level 2 of the Maternity and Gynaecology building, colour coded by room use. Total area: 2162.52 m<sup>2</sup>. Cutaway shows the focus area of the study and the symbols for sensors and locations are described in Table 1. The map is based on building plans provided by RBH.

The focus area of the study was the waiting/reception area (capacity: 20–30 people) and staff break room (capacity: 10 people) associated with the ultrasound scanning rooms (6 rooms, 4 sealed, 2 naturally ventilated) on Level 2, the ground floor (Figures 1 and 2). The only rooms with windows are the ones directly connected to the building façade, in this case, the two staff offices (Figure 2, marked as SO1, SO2 respectively). Only the scanning rooms without direct natural ventilation (four) are monitored. These are positioned within the centre of the building (Figure 2). Room 3 (Marked as Sensor SR3) has air-conditioning available to use, with a portable air-conditioning unit also being deployed (unknown date of deployment and operation times) in the waiting room in front of the reception desk (Figure 2). Sensor naming convention is shown in Figure 2. Occupants of these areas include admin, cleaning, and clinical staff (all day), patients and pregnant patients (<5 h stay), all of whom will be negatively affected by high indoor temperatures [40]. Varying environmental conditions have also been reported across the entire floor and building (Figure 2).

Natural ventilation is not a viable solution in this area of the RBH, due to the central position of the at-risk scanning rooms within the building (Figure 2). Also, within heatwave conditions, it is expected that air-pollution also increases, adversely affecting those with respiratory conditions [18]. Refs. [24,45,46] highlight that there are few examples of innovative natural ventilation/passive cooling strategies being used in hospital buildings, due to risk-adverse procurement and tight budget constraints. Noise may also prevent windows and doors from being opened. Whilst this study has focused on temperature, other factors, such as airflow, moisture, and odour also influence thermal comfort and may also need to be considered for specific patient groups. Other more complex ventilation solutions are described in [45].

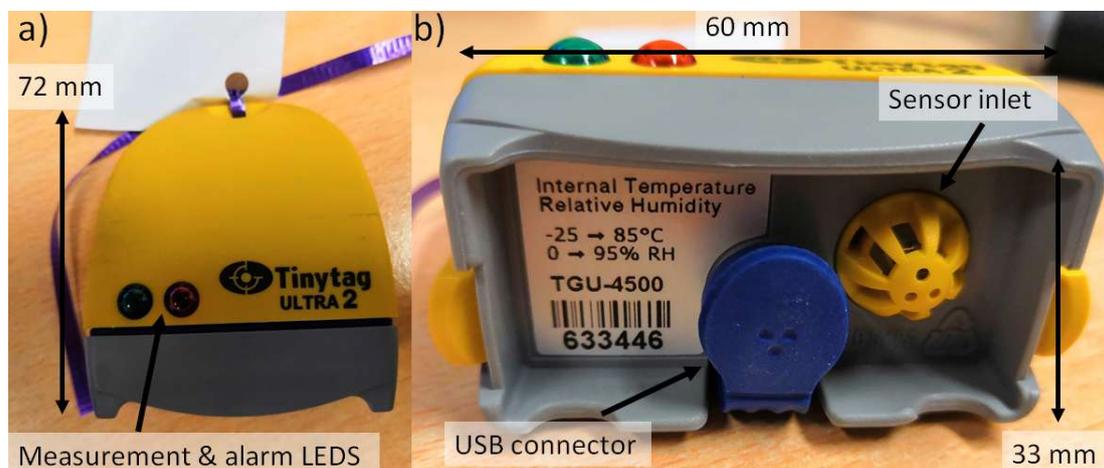
**Figure 3.** Images of the Tinytag sensors deployed (a) plan view and (b) closeup of the sensor base where the inlet is visible. All sensors had a piece of paper attached describing what they were measuring and who to contact if issues arose.

Temperature and humidity within the internal environment were measured using nine Gemini Tinytag Ultra 2 TGU-4017 temperature loggers (temperature range −40 to 85 °C) chosen for their

splash-proof case, self-contained design and USB (Universal Serial Bus) connection (Figure 3). Where possible sensors were positioned out of direct sunlight (only a problem for the Staff Offices, see Figure 2) and away from windows or any office equipment which may generate waste heat. Within the waiting room, the sensor was placed in the corner of the room, out of sight, but within the area where patients sit and wait.

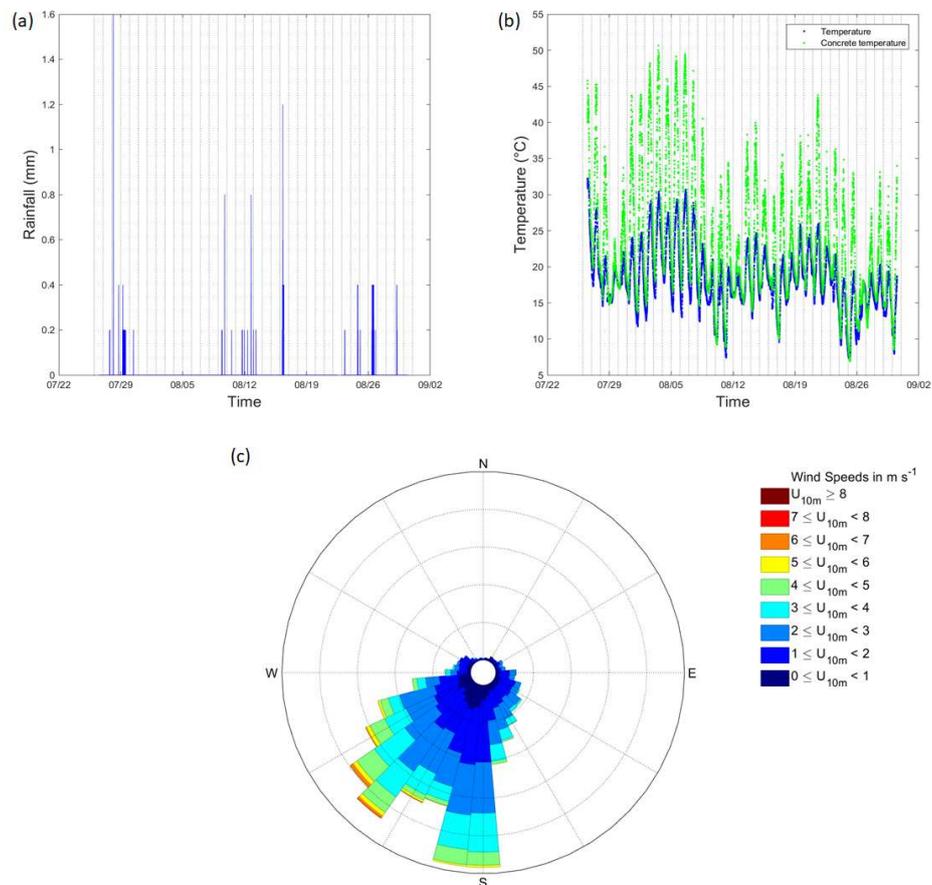
**Figure 5.** Observations from UoRAO for the study period. (a) rainfall, (b) temperature and concrete temperature, and (c) wind direction and 5-min wind speed at 10 m (meteorological standard). Vertical grey lines denote midnight of each day.

Reference external temperatures were measured at the University of Reading's Atmospheric Observatory (UoRAO), also at five-minute intervals as part of the automated system (accuracy: 0.1 °C). The temperature of concrete was also logged. The climate conditions of Reading can be classed as temperate. UoRAO is approximately 1.5 km as the crow flies from the Maternity and Gynaecology building (Figure 4). For details on the experimental set up of the UoRAO and measurements available see [41]. Whilst this distance is small, the external temperatures around the hospital site may be slightly warmer due to the urban heat island effect. Figure 5 details the background weather conditions throughout the campaign, with little rain being recorded (Figure 5a). Low wind speeds (95 % were  $<6 \text{ m s}^{-1}$ ) were recorded throughout the study period and for most of the study period, the wind direction remained within the prevailing sector for the area (Figure 5c).

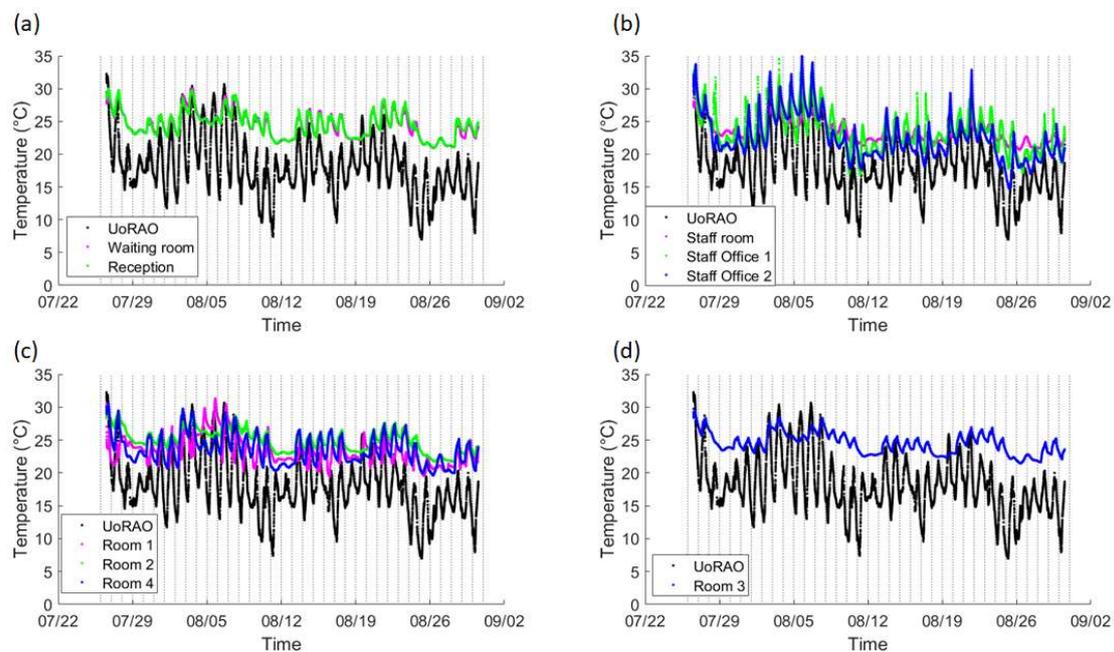
**Figure 6.** Overview of the temperatures recorded for the entire study period. Vertical lines denote midnight of each day. For clarity, similar rooms are plotted on one subplot, (a) Observatory (UoRAO), waiting room and reception, (b) UoRAO and Staff room and offices, (c) UoRAO and the naturally ventilated scanning rooms (Room 1,2,4) and (d) UoRAO and room 3, the air-conditioned room. All plots have the same axis.

A diurnal cycle is present for all rooms, with more extreme temperatures being seen in the Staff offices, due to them being located on the building's exterior (Figure 2, Figure 6b). The staff offices are also where the lowest indoor temperatures are recorded during the evenings, due to the rapid release of heat from the building's surface and potential ventilation. The waiting room and reception area (Figure 6a) both record similar conditions due to them being linked, with the waiting room having lower minimum temperatures due to it being closer to the main entrance (automated sliding double doors ~1.5 m across) and the effect of the temporary air-conditioning unit (Figure 2). The staff room also displays a similar trend, though with larger daytime spikes due to the lack of ventilation because of closed doors for privacy and security reasons (Figure 7b). The ultrasound scanning rooms all show slightly different behaviours, with room three displaying lesser peaks due to the use of air-conditioning, but even with air-conditioning, there is still a notable peak throughout the day, suggesting the current unit is struggling to maintain temperatures, even in the smallest scanning room (Figure 6c,d and Table 1).

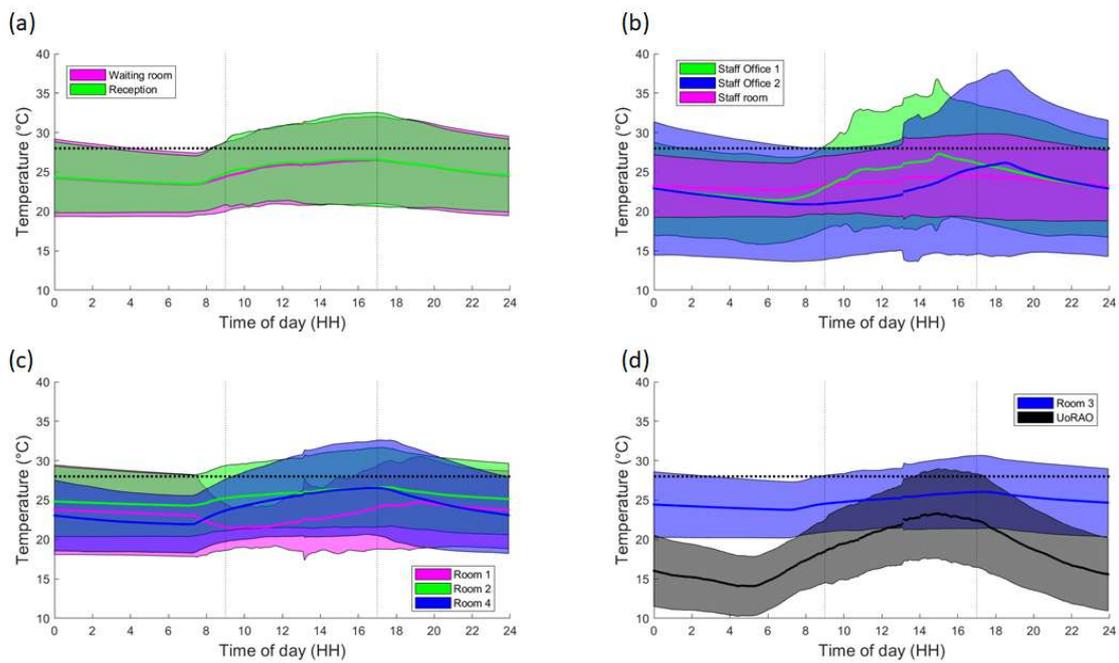
**Figure 7.** Time-averaged trend of weekday temperatures within the rooms. Line denotes the mean temperature per five minutes, with the shading denoting three standard deviations. (a) Waiting room and Reception, (b) Staff offices and the Staff room, (c) Rooms 1, 2 and 4 and (d) Room 3. Note that for clarity the UoRAO data is on plot d). Clinic hours are highlighted by the dashed vertical lines. The CIBSE threshold of 28 °C is shown in the thick horizontal dashed line.

Removing the weekend data and averaging over all weekday data further highlights the differing behaviour of the scanning rooms throughout clinic times (Figure 7c,d). On average staff office 1 experiences a peak in mean temperatures at around 15:00, whereas Staff office 2 peaks between 18:00 and 19:00 (Figure 7b, Figure 8b), with some of the highest maximum temperatures (30–35 °C) being recorded here (Figure 9b). This is most likely due to the solar gain of those offices. Based on room positioning time of year, Staff office 1 would have maximum solar gain between 11:00–14:00 (south-facing) and Staff office 2 (west-facing) 16:00–19:00. Staff office 2 also experiences the lowest temperatures, which is a concern for the winter months, as, despite windows being closed, it is a similar temperature to UoRAO temperatures during the evening (Figure 7b). More research into occupant adaptation and behaviour is required.

The staff room has a peak in temperature at around 14:00, linked to anthropogenically created heat from lunch breaks between 12:00 and 14:00 (Figure 7b, Figure 8b). The waiting room and reception areas experience a slow rise in temperature throughout clinic times (Figure 7a), with maximum temperatures occurring most frequently between 12:00 and 17:00, in part due to the presence of people (Figure 8a). This rise in temperature is less steep than the scan rooms (Figure 7c) due to the proximity to the entrance doors, less equipment, and the influence of the portable air-conditioning unit installed within the waiting area.

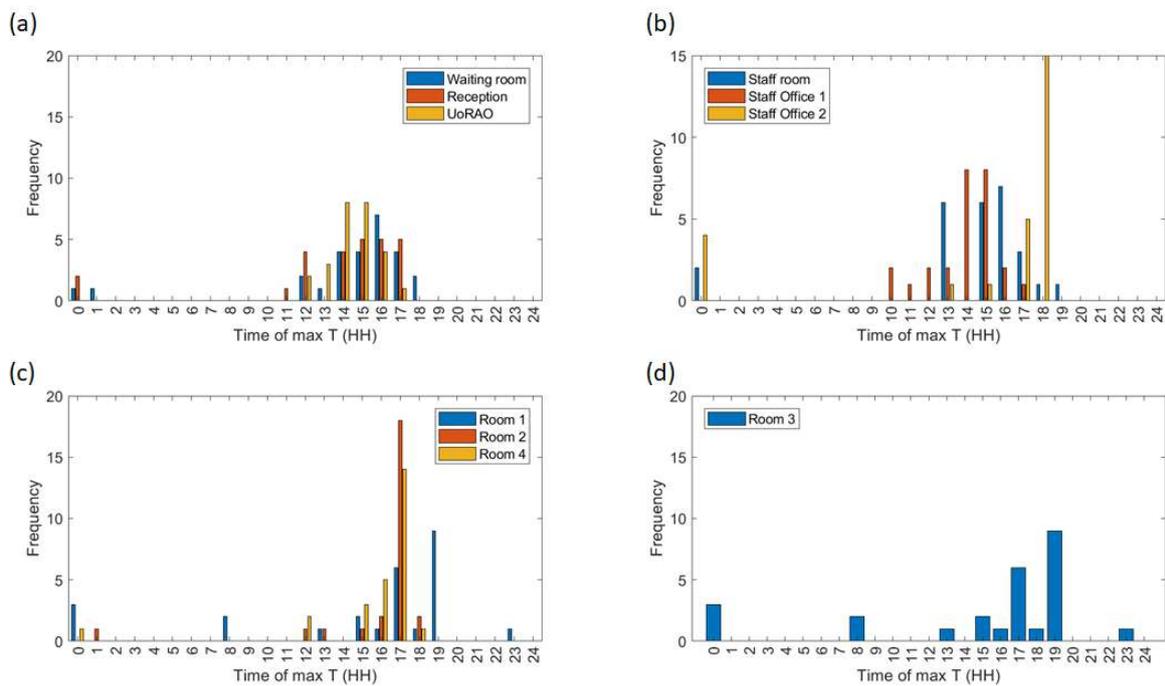
**Figure 8.** Hours in which the maximum daily temperatures recorded on the weekdays occur (Figure 9). For clarity, similar rooms are plotted on one subplot, (a) Waiting room, Reception and the observatory (UoRAO), (b) Staff room and Staff offices, (c) Room 1, 2, 4 and (d) Room 3. All plots have the same axis.

A large variation is seen in the daily average temperatures for scanning rooms 1, 2, and 4, with all tending towards a peak in mean temperatures at 17:00 (Figure 8c), an accumulation of high external temperatures, waste heat from equipment and anthropogenic heat (Figure 7c). Scan room 3's mean temperature is kept fairly constant due to the air-conditioning unit (operated by staff, with heat extracted to the roof) with its most frequent daily maximum temperatures being 1–2 °C lower than the other rooms (Figure 9c,d). Differences between rooms 1, 2, and 4 are likely due to differing usage patterns, size, staff preference, location of different equipment, and differing structure (Figure 2). The time of the daily maximum temperatures of Scan room 3 is slightly later than the other rooms, due to the air-conditioning unit being turned off after clinic hours and the room returning to equilibrium (Figure 8d).

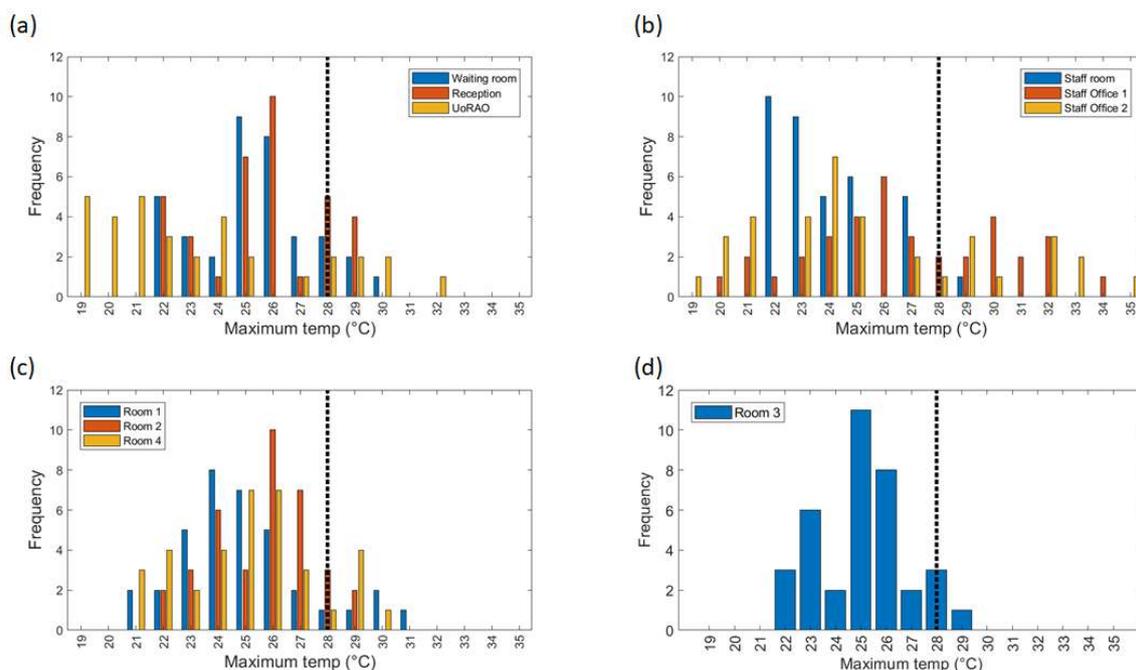
**Figure 9.** Maximum daily temperatures recorded in all rooms across all weekday measurements. For clarity, similar rooms are plotted on one subplot (a) Waiting room, Reception and the observatory (UoRAO), (b) Staff room and Staff offices, (c) Room 1, 2, 4 and (d) Room 3. All plots have the same axis. The vertical dashed line denotes an upper threshold of 28 °C.
